3000 Series TS-1 Firmware v3.6

Peek Traffic is pleased to announce the release of Version 3.6 of the TS-1 firmware for the 3000 Series Traffic Controllers. The primary purpose of this release is to improve communications reliability, but it also adds a couple of new overlap modes, improves the onscreen interface, and corrects a few issues reported in previous versions of the firmware.

Product.....TS-1 Firmware for 3000 and 3000E Traffic Controllers
VersionVersion 3.6
Release Date 11/23/04

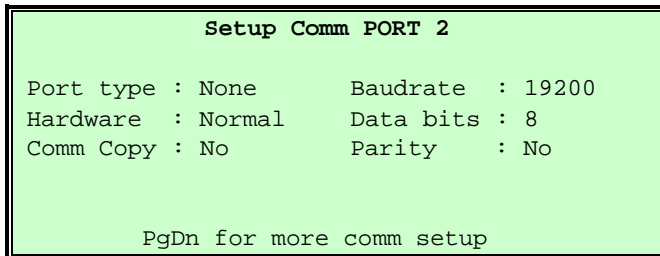
Figure 4 – Comm Port 2 Setup screen

Whenever Port 2 on the front of the 3000 Series controller is accessed, these settings are used. Use the arrow keys to navigate, and the Y/N key to change the value for a parameter.

Port type – This setting is only used by the controller when it is set to 'Monitor', indicating that an intersection monitor is connected via this port. Note that this setting also allows a monitor to be connected via a modem (if anyone would want to do so.)

Baudrate – Sets the data transfer speed for this port. The firmware will accept values of : 1200, 2400, 4800, 9600, 14400, 19200, 38400, 57600, and 115200 baud. (But the selected rate can only be achieved if the device attached to this port can also communicate at this speed.) This parameter is not displayed if Hardware is set to Ethernet.

Comm Copy – This setting replaces the parameter in the Closed Loop Master/ID screen called 'Allow Comm Transfer Between Ports 2&3'. What this command does is tell the controller to echo the input on this port to the other port. (This works for data input to either port.) Although this setting appears on both the Port 2 and Port 3 screens, there is only a single value for this parameter in the database. So setting this value to Y or N on one port automatically sets it to the same value on the other port.

The Comm Port Setup screens have been reorganized so the parameters are easier to understand and use. Previously, when one entered the Comm Setup Screens from the Communications & System Setup menu (MM > 3 > 5 > 2), the controller presented four setup screens (accessible by paging down.) The first of these was a screen where the Master Port, Monitor Port, and Central Port were assigned. This screen has been removed. Now, the controller goes straight to the Comm Port 2 Setup screen:

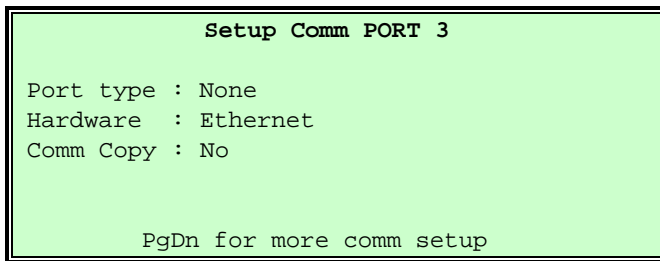
The Setup Comm Port 3 screen is identical to the Port 2 screen, except that there is an additional Hardware setting: Ethernet. If Hardware is set to Ethernet, the right column parameters are hidden. (Ethernet forces these values to their fixed Ethernet values: 115200, 8, No.)

Figure 5 – Comm Port 3 Setup screen with Hardware set to “Ethernet”

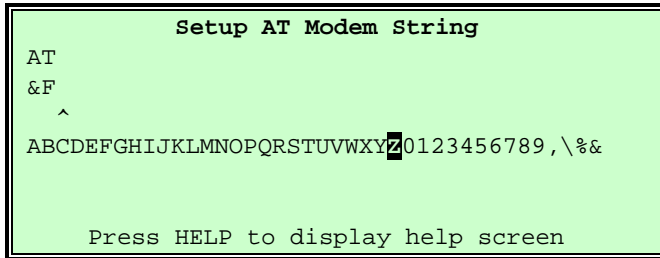
Paging down yet again will take you to the screen where the modem’s ‘AT’ setup string is entered. In firmware v3.6, this screen has been modified to make it easier to enter the desired string. (Note that the firmware automatically puts an ‘AT’ at the beginning of this string, so you do not need to enter these letters.)

The caret symbol (^) shows where the next character will be added on the third line. To add a character, move the highlight cursor (within the alphabet listing) to the desired letter, using the left and right arrow keys, and press **ENTER**.

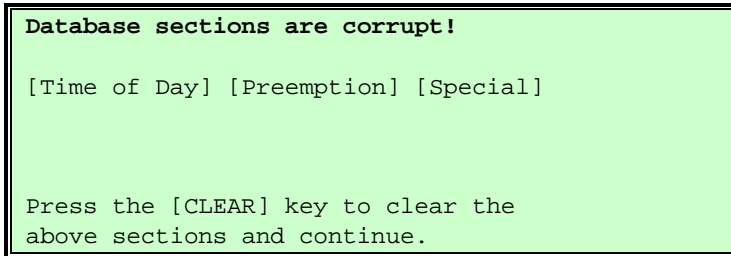
In previous releases of the 3000 series firmware, the configuration databases in the controller were tested every time the system was started using a confusing set of ‘Checksum tests’ and tools in the controller screens that could be used to override they tests if any errors were found. But now, in the version 3.6 release, the firmware simply tests the controller databases upon startup (there are seven of them) and reports immediately if any problems are found. If any problems are discovered, an error screen appears, showing all of the databases where problems were detected. This is what the screen looks like when (for example) three of the databases have errors:

Figure 6 – Power-on Self Test Error Message with 3 database errors detected

Unlike before, when the controller started up even if it did detect a ‘Checksum’ error, and the operator had to look very carefully at the main dynamic status screen to see if there were problems, the new system uses a CRC test (Cyclic Redundancy Check) and it won’t allow you to start the controller unless you acknowledge that you’ve seen the error by pressing the CLEAR key. This also clears the database contents to a blank state. This is judged to be safer than to allow a corrupted database to be used to run an intersection (as was sometimes done in the past.)
